ANNUAL REPORT FOR 2015

Middle Fork Creek Site A Mitigation Site Madison County TIP No. R-2518A

Prepared By:
Natural Environment Section & Roadside Environmental Unit
North Carolina Department of Transportation
November 2015

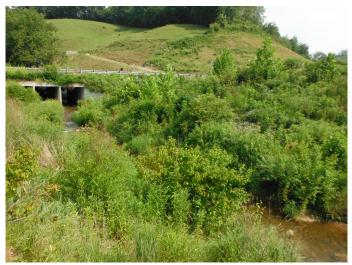
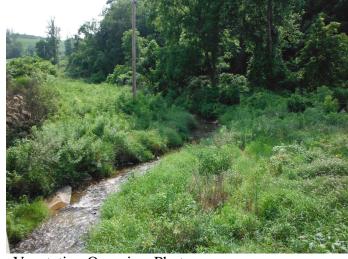
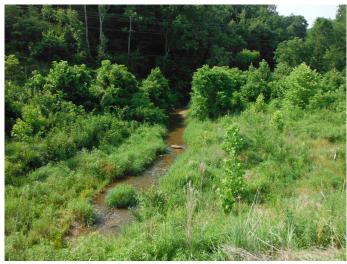
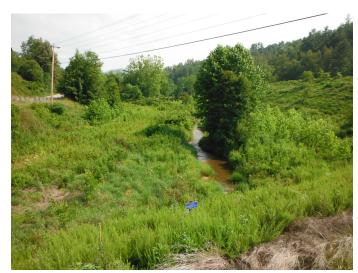
Streambank & Buffer Vegetation: The streambank reforestation was completed in March 2012. The Year 4 vegetation monitoring evaluation noted: Type I: Black Willow, Silky Dogwood and Type II: Sycamore, Green Ash, Tulip Poplar and White Oak were surviving at the time of the monitoring evaluation. There was no Japanese Knotweed noted onsite at the time of monitoring.

Vegetation Overview Photo
